338 345 kV Line Asset Condition Refurbishment

National Grid

November 20, 2024

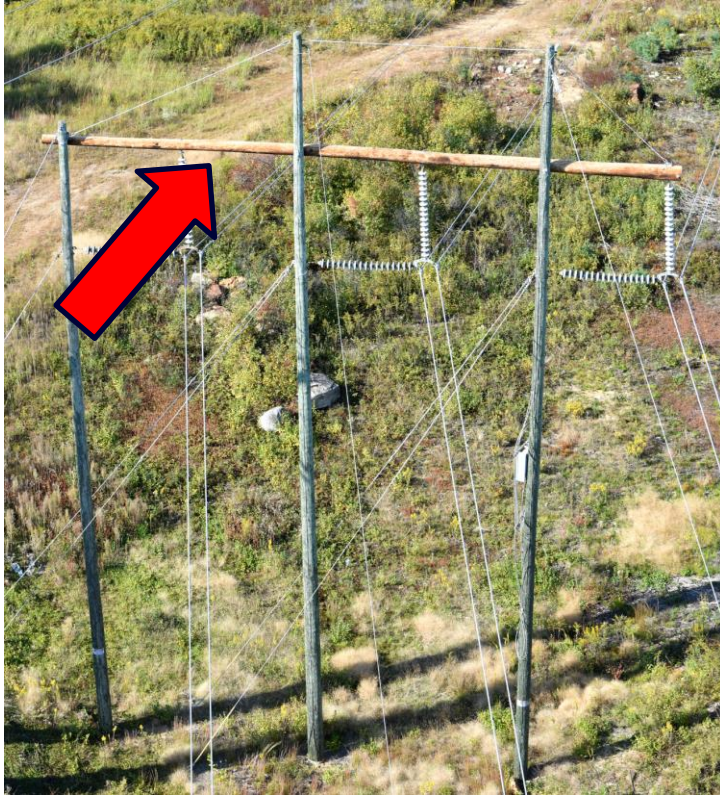
Str. 95

These structures use a wood pole as a crossarm which is prone to failure. Water collects in the side grain on the upper side of the arm and rots the wood prematurely.

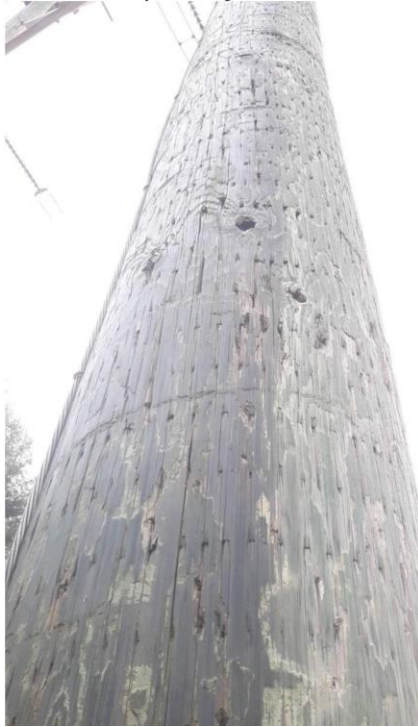
Str 67

Woodpecker, checking, deterioration

Woodpeckers pose a significant threat to wood poles of any age. Their increasing population is accelerating the degradation experienced by wood poles. While moisture-based decay happens near groundline, damage from woodpeckers occurs higher up on structures where they can be more difficult to identify.

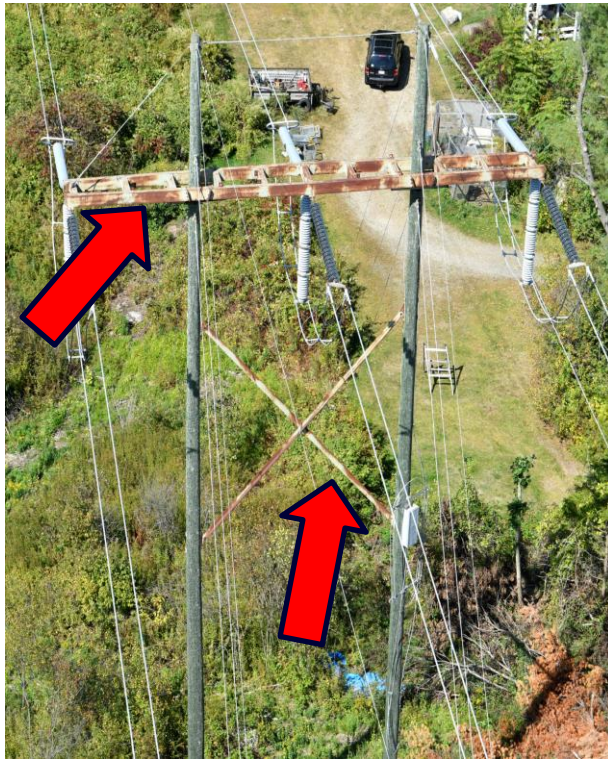
Str 67

Rust on steel crossarms and x-braces

Rust on crossarms and x-braces increase the chances of structure failure and must be addressed to ensure reliable performance of the line

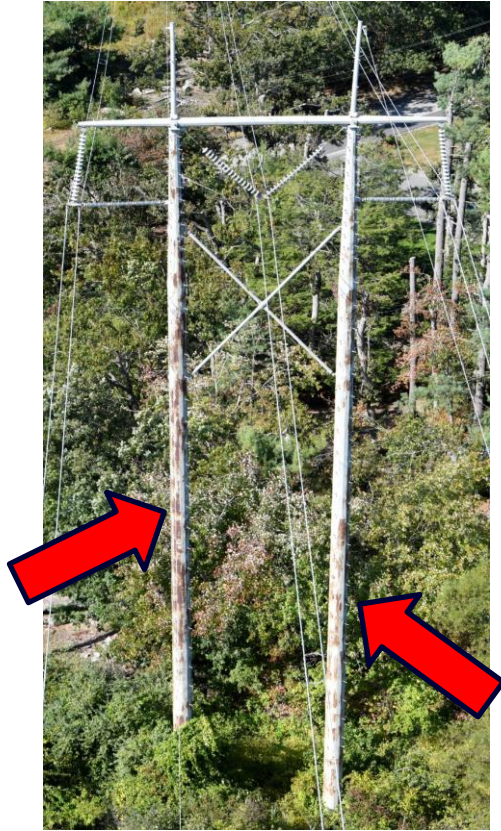
Str 78

Rust on steel structures
